**LANDSLIDE INVESTIGATION AND HAZARD
ZONATION IN THE GREYMOUTH URBAN AREA.**

A thesis
submitted in partial fulfilment
of the requirements for the degree
of
Master of Science in Engineering Geology
at the
University of Canterbury
by

**University of Canterbury
1993**

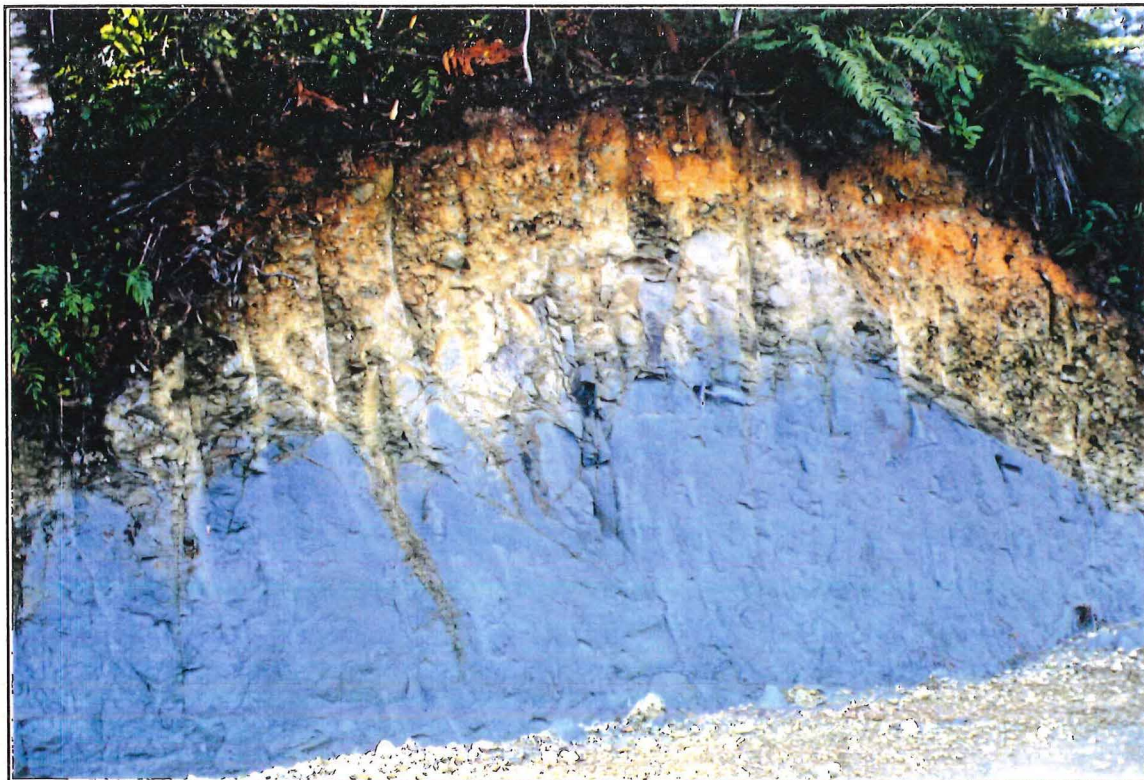
Figure 2.3 Typical exposure and weathering of the Stillwater Mudstone. Note highly fractured nature of the outcrop and lack of defect continuity. Defects are zones of alteration within the rock mass.

Weathering of Stillwater Mudstone (Figure 2.3) may extend to greater depths ($\leq 4\text{m}$) than within Cobden Limestone and is of particular significance in relation to slope stability. Jointing appears to allow ground water into the rock mass generating high pore pressures leading to weakening and disintegration of the rock material by slaking. The resulting *in situ* or colluvial products commonly become destabilised under changing conditions such as removal of the vegetation cover, during high rainfall or in cut slopes accompanying urban development.

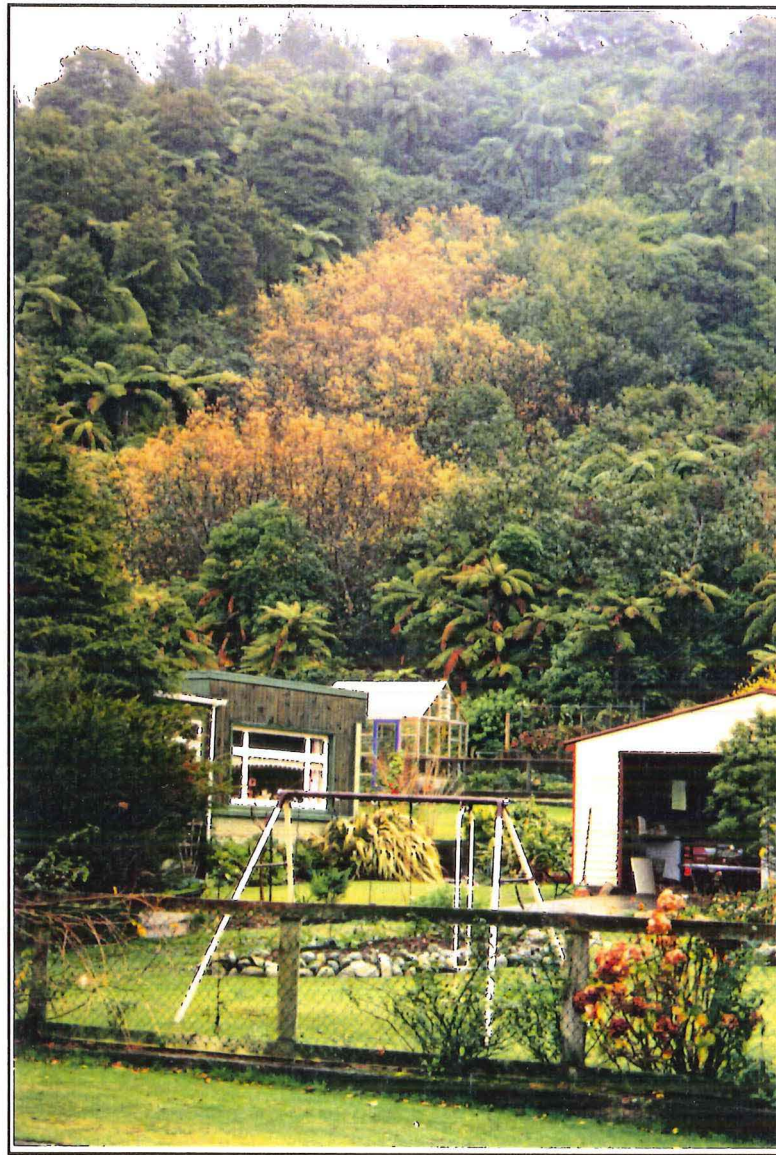
Figure 3.4 A landslide near Boddytown that was identified from localised and distinct changes in vegetation patterns.

In areas of dense vegetation, it was possible to infer landslide features on the basis of localised changes in the vegetation cover (Figure 3.4). In general, however, the vegetation (especially gorse and blackberry) hindered field investigation for two reasons. Firstly, the dense nature of the undergrowth, particularly in areas of regenerating forest, prevented site access and secondly, the vegetation obscured landslide morphology. It is therefore likely that some landslides have still not been identified during field mapping.

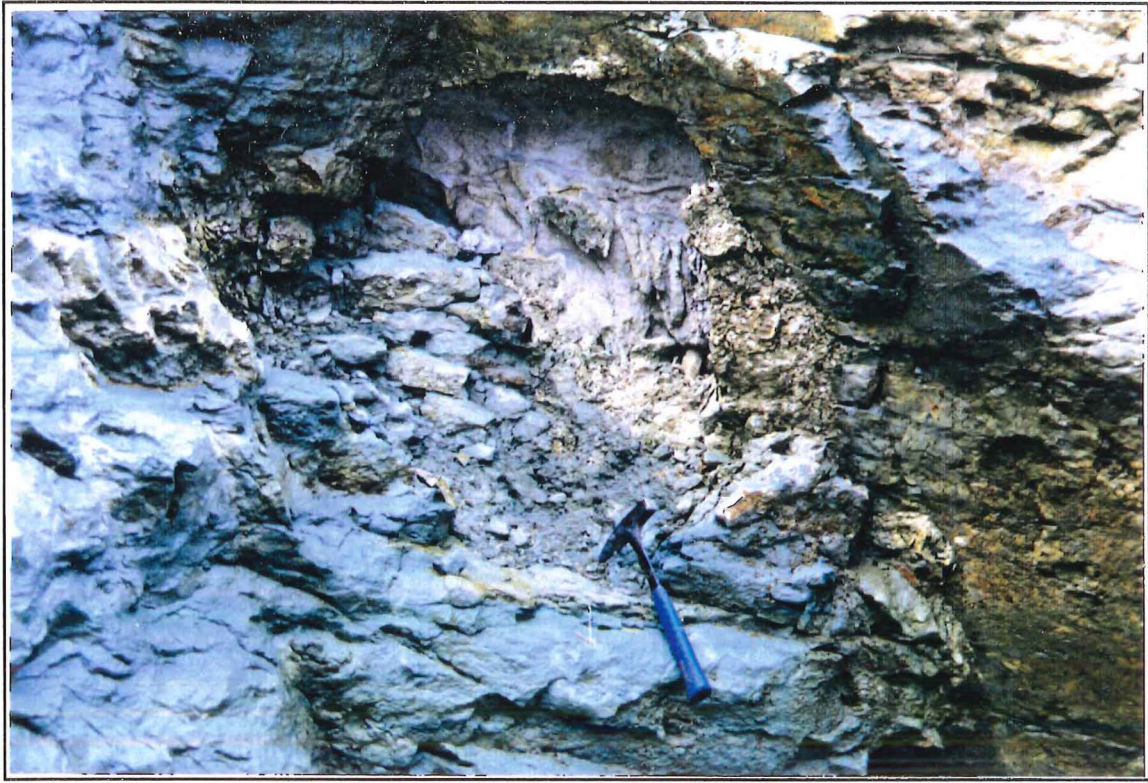
Figure 3.6 Small sink hole developed in the Cobden Limestone. This was exposed during foundation excavation for a retirement home in the Puketahi Street area.

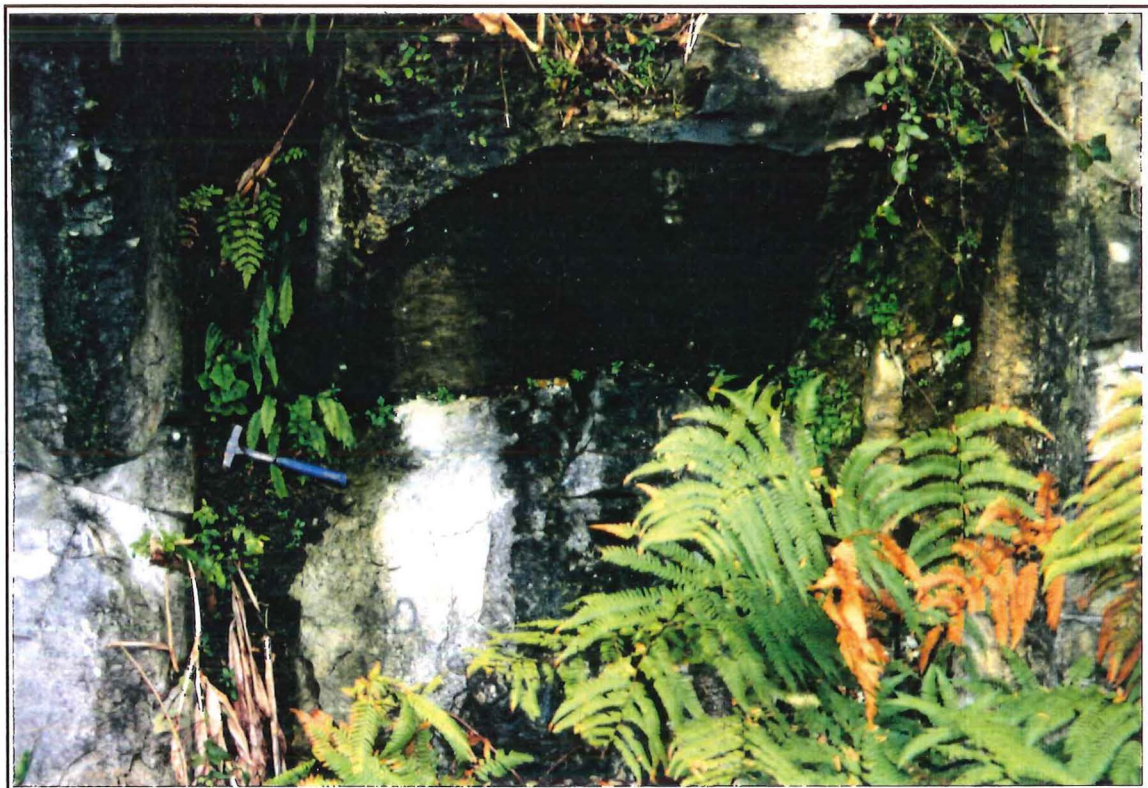
Figure 3.7 Joint relaxation in the Cobden Limestone in the Mount Street area. The joints have been infilled with material washed down from above. Note the regular spaced jointing in the limestone.

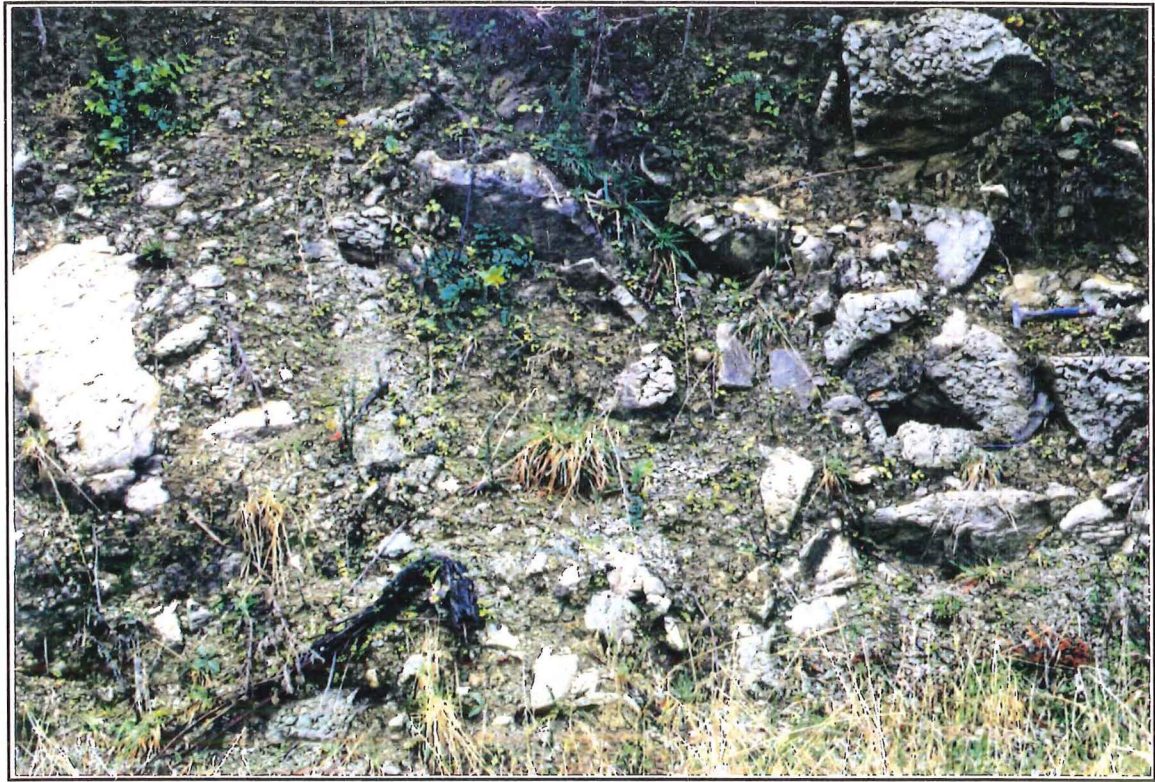
Figure 4.1 Rock avalanche debris forming a blocky limestone colluvial deposit.

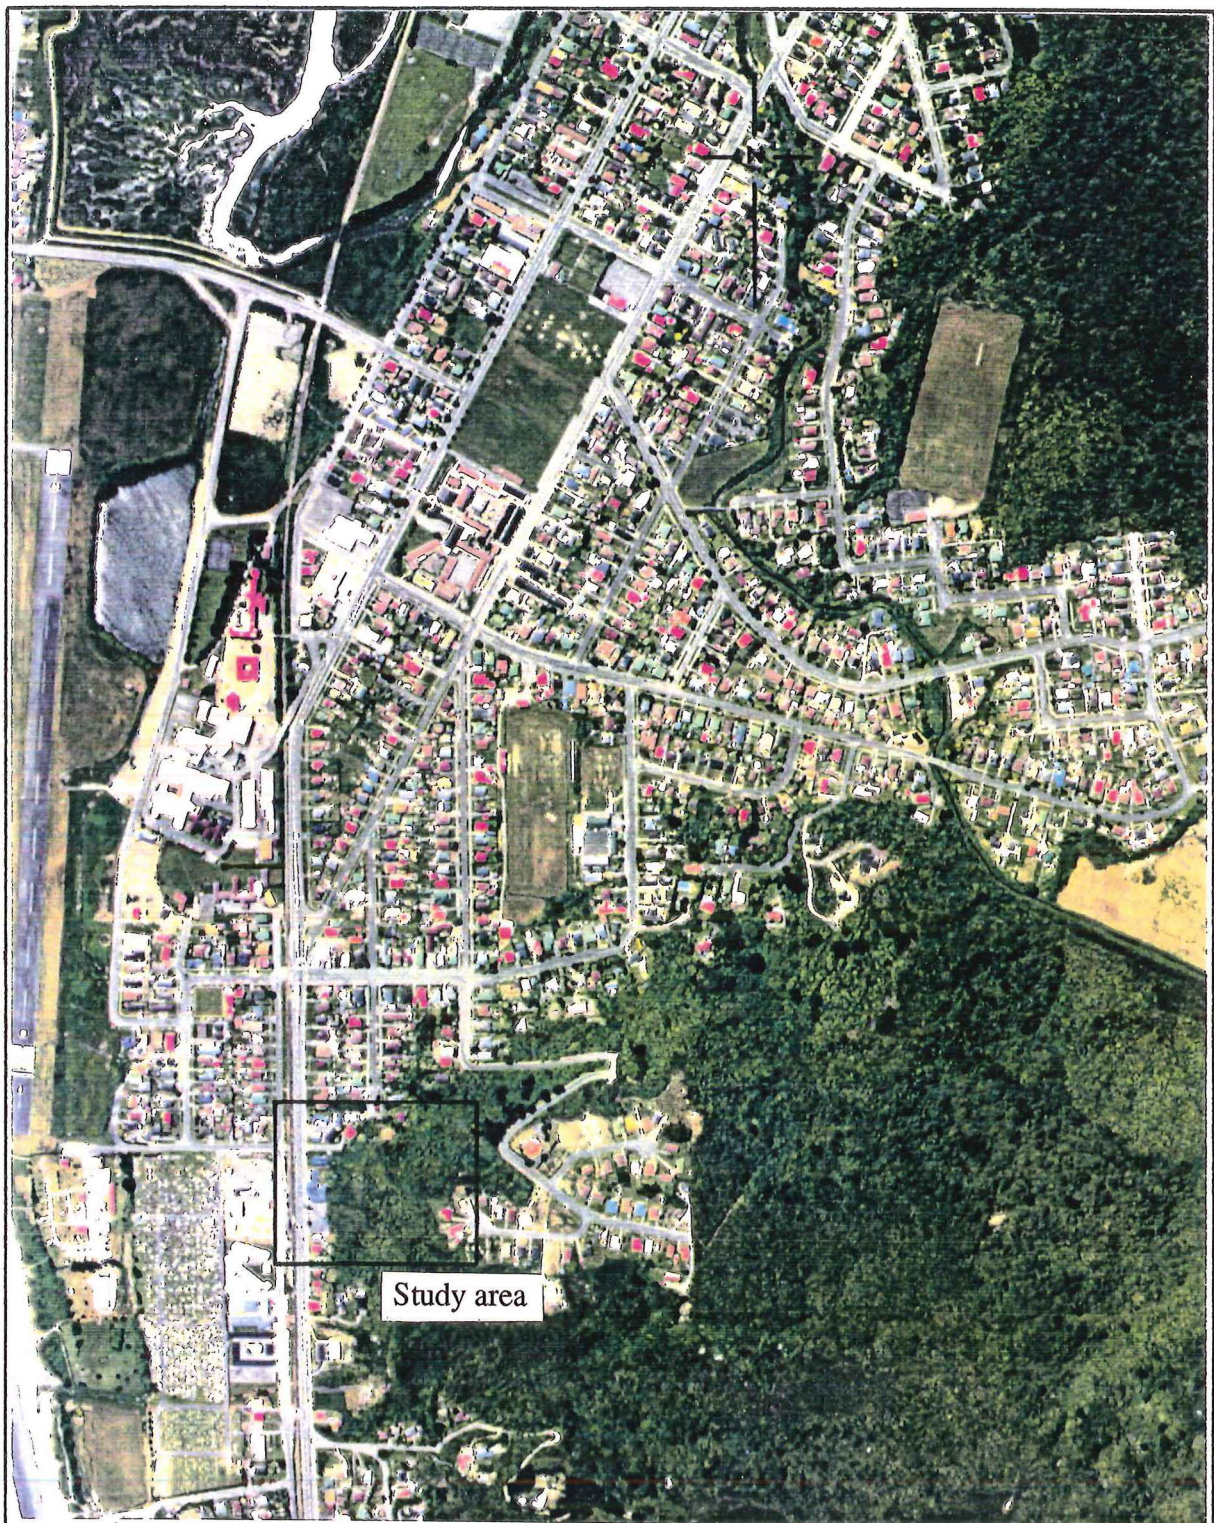
Figure 4.7 A vertical aerial photograph illustrating the location of the Australasian Hotel Slide field area. The photograph was taken in 1992 at a scale of 1:10000 by The West Coast Regional Council.

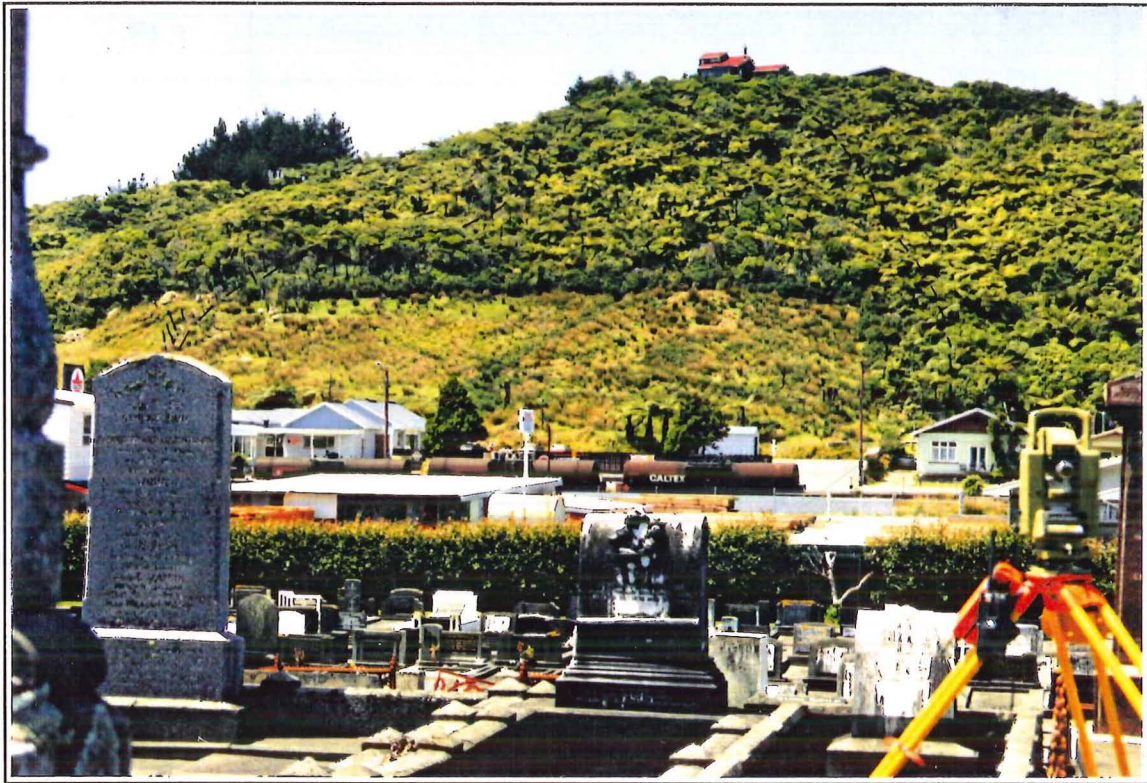
Figure 4.10 Surveying in progress on the Australasian Hotel Slide. The slide surface is outlined and the position of the prism is arrowed.
